# New York State Department of Transportation

## Red Flag NB23U4W024

**BIN: 1065318**

Location: Span 236 Girder G1 at Pier 236.

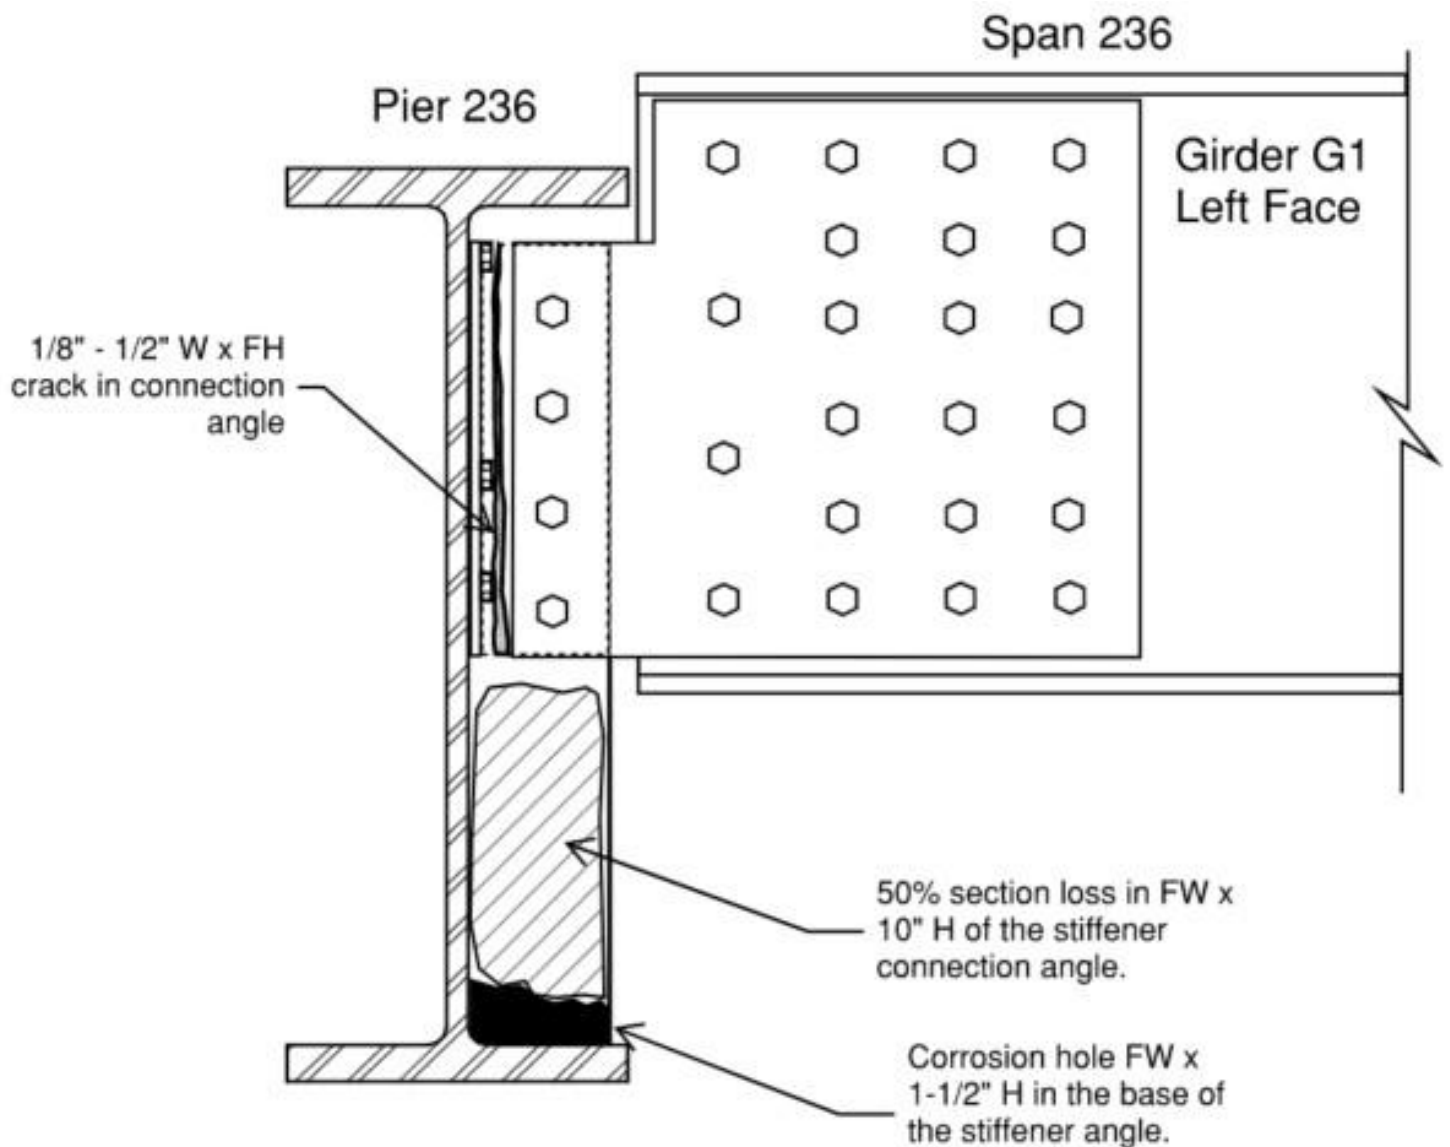
Photo Number: 2

The left connection angle of Girder G1 at the connection to Pier 236 exhibits a full height vertical corrosion crack for 1/8"-1/2" wide along the entire fillet section (previously 3" long x 1/2" wide vertical corrosion crack at the lower fillet section).

**SKETCH FOR RED FLAG # NB23U4W024**  
**SPAN 236, GIRDER G1 BEAM END AT PIER 236**  
**(LOOKING RIGHT)**  
**N.T.S**

*Attachment Description: Flag Condition Sketch 1*

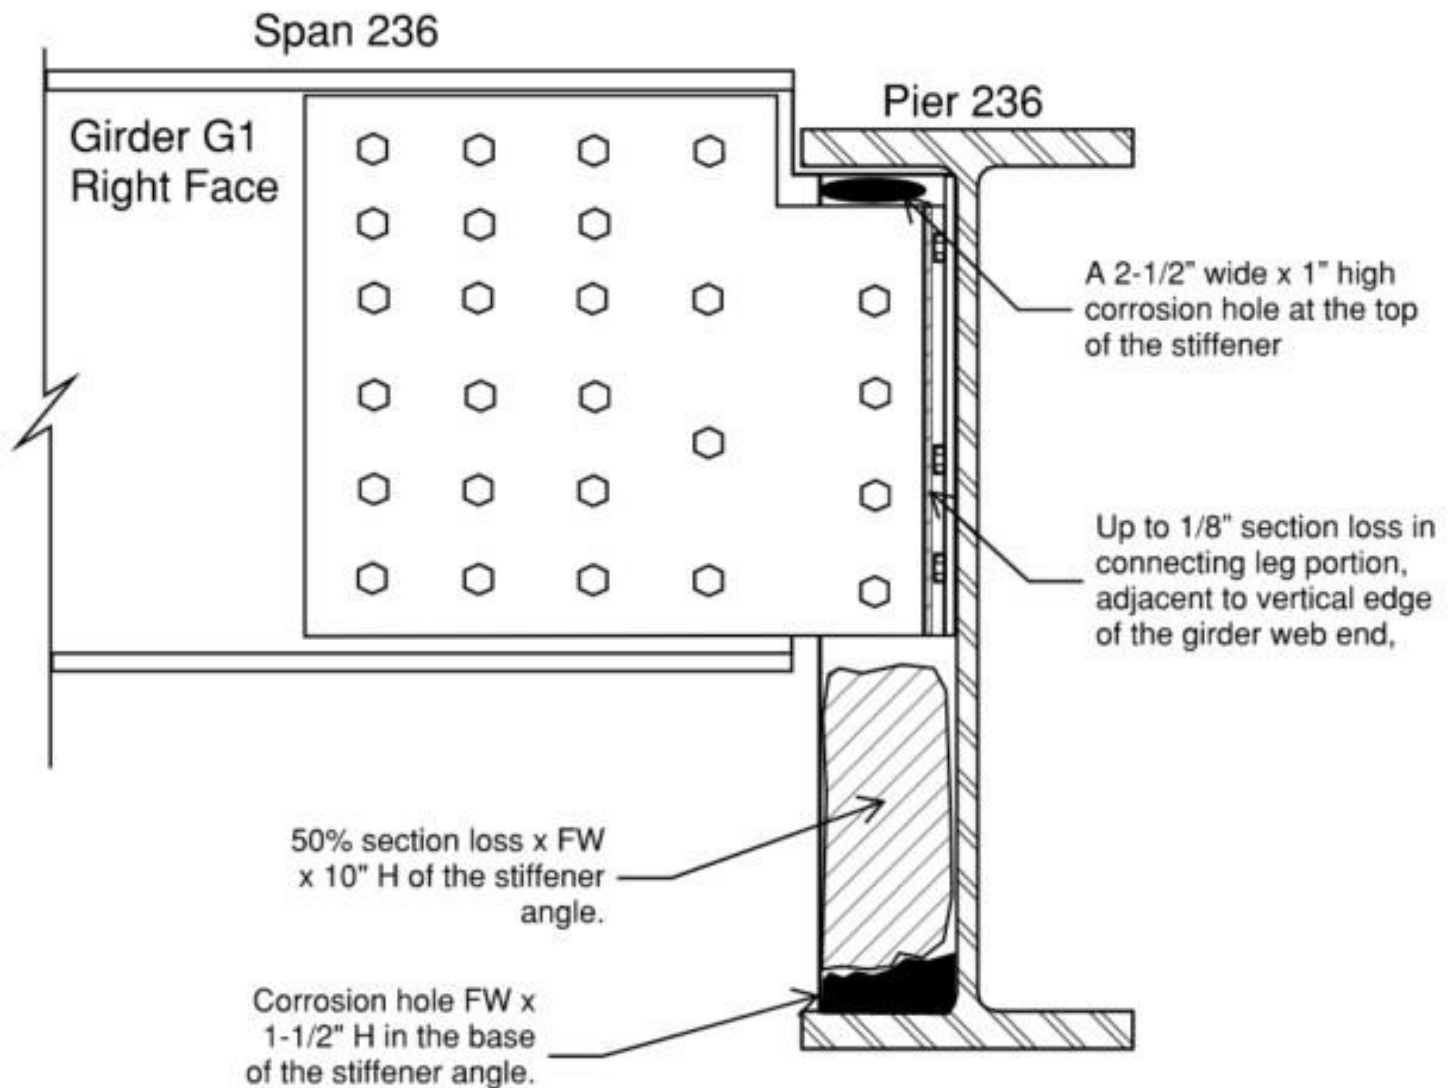
Photo Number: 3

1. up to 1/8" section loss in the connecting leg portion, adjacent to the vertical edge of the girder web end,
2. heavy section loss (up to 50% section loss) in the lower portion of the connecting leg (FW x 10"H), below the girder web connection.
3. connecting leg has a Full Width x 1-1/2" high corrosion hole at the base (previously 4" wide x 1-1/2" high hole) and a 2-1/2" wide x 1" high corrosion hole at the top of the stiffener (previously, a 4" wide x 1-1/2" high hole at the base and a 2" wide x 1" high corrosion hole at the top of the stiffener).

**SKETCH FOR RED FLAG # NB23U4W024**  
**SPAN 236, GIRDER G1 BEAM END AT PIER 236**  
**(LOOKING LEFT)**  
**N.T.S**

*Attachment Description: Flag Condition Sketch 2*

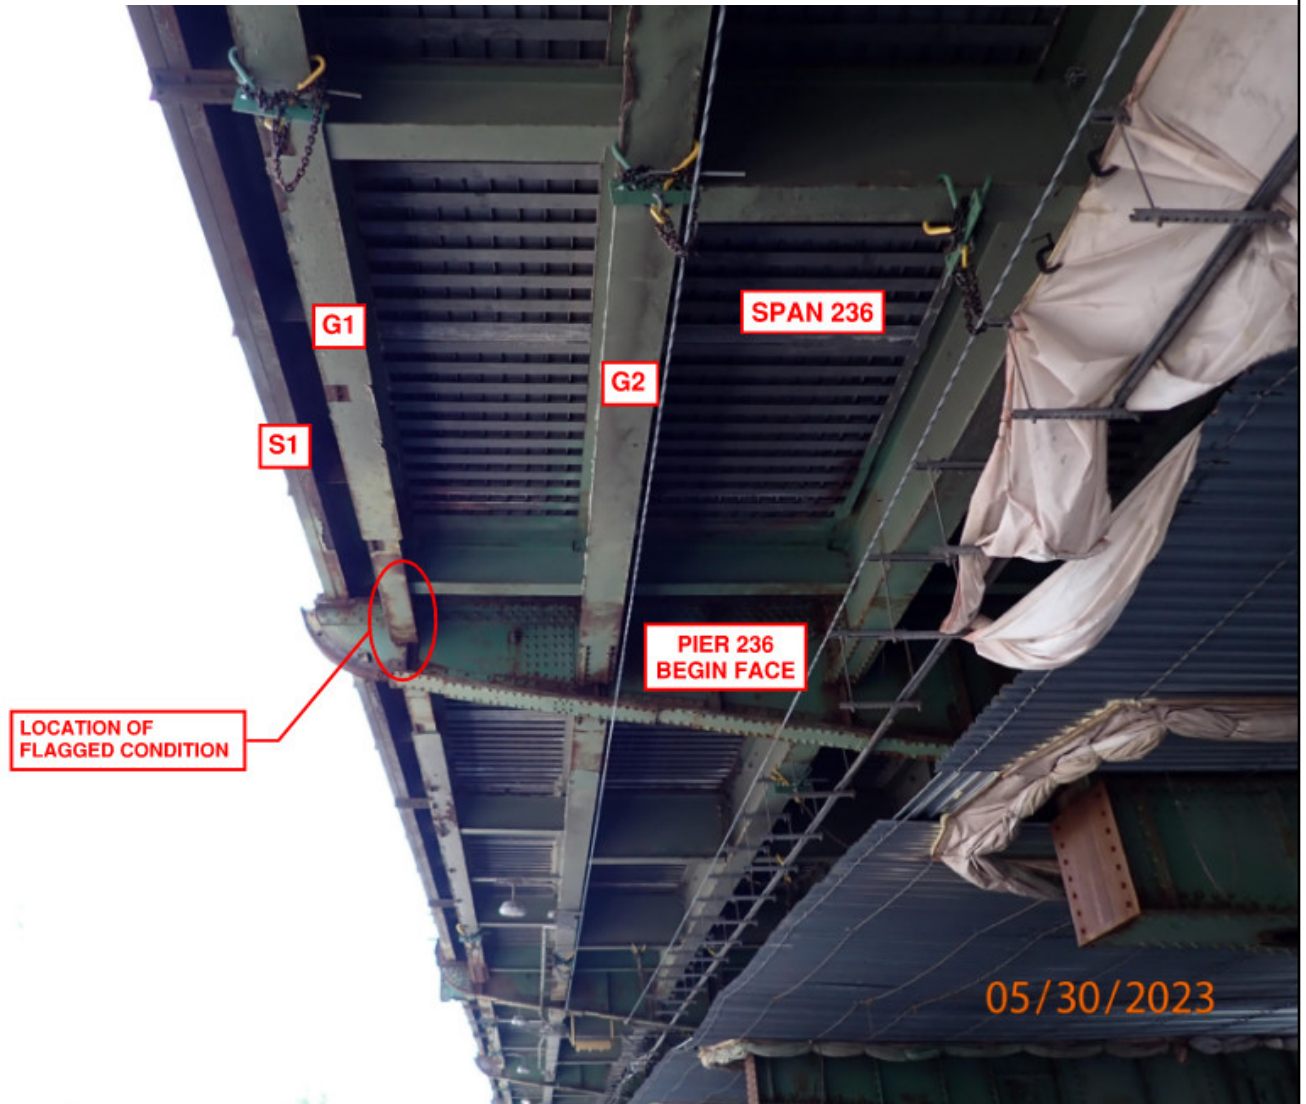
Photo Number: 4

**Attachment Description: General View of Flag Condition. Looking End - Up**

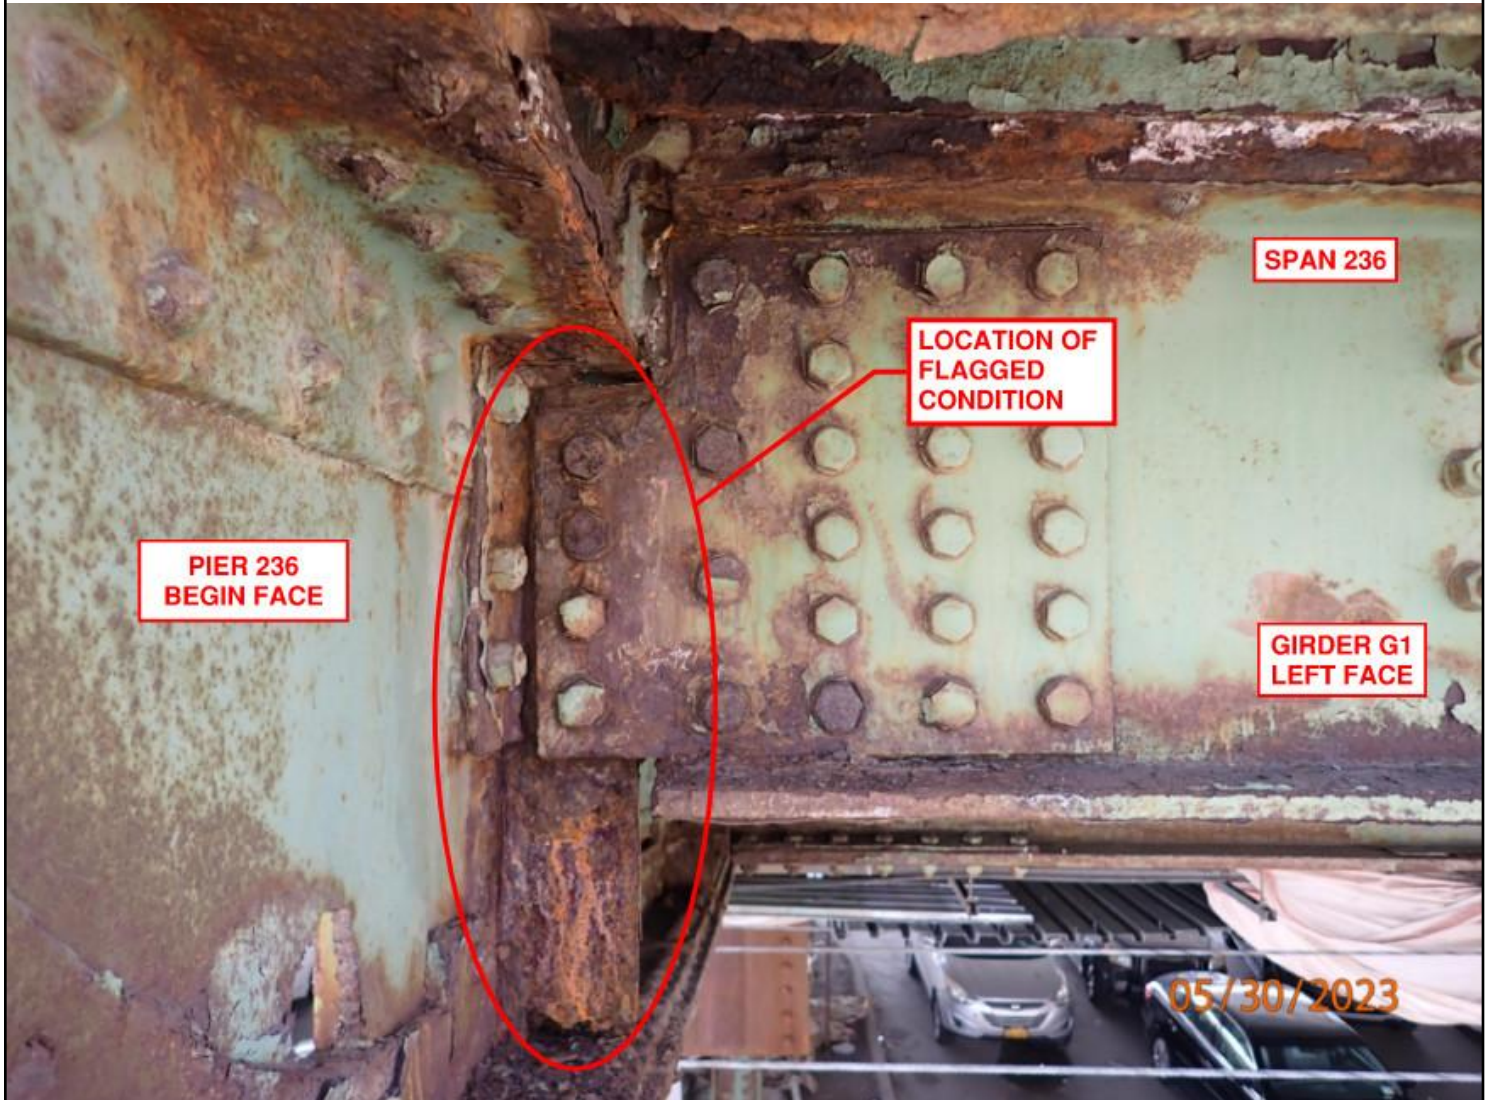
Photo Number: 5

**Attachment Description: General View of Flag Condition on Girder Left Face. Looking Right.**

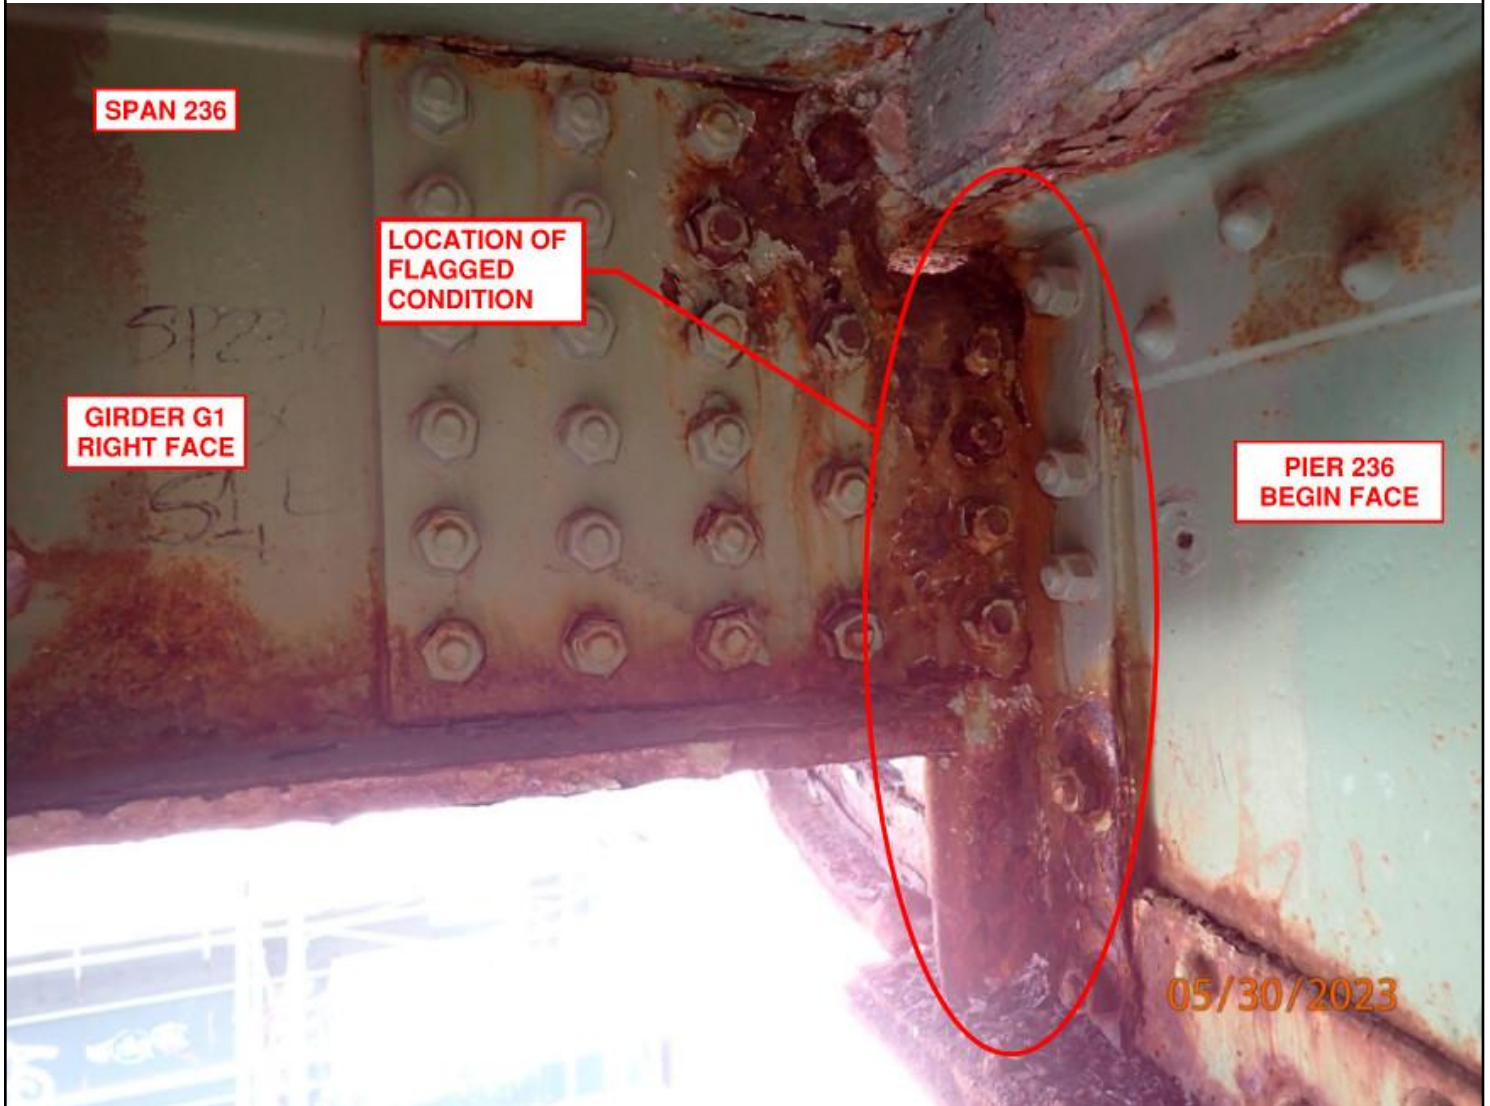
Photo Number: 6

**Attachment Description: General View of Flag Condition on Girder Right Face. Looking Left.**

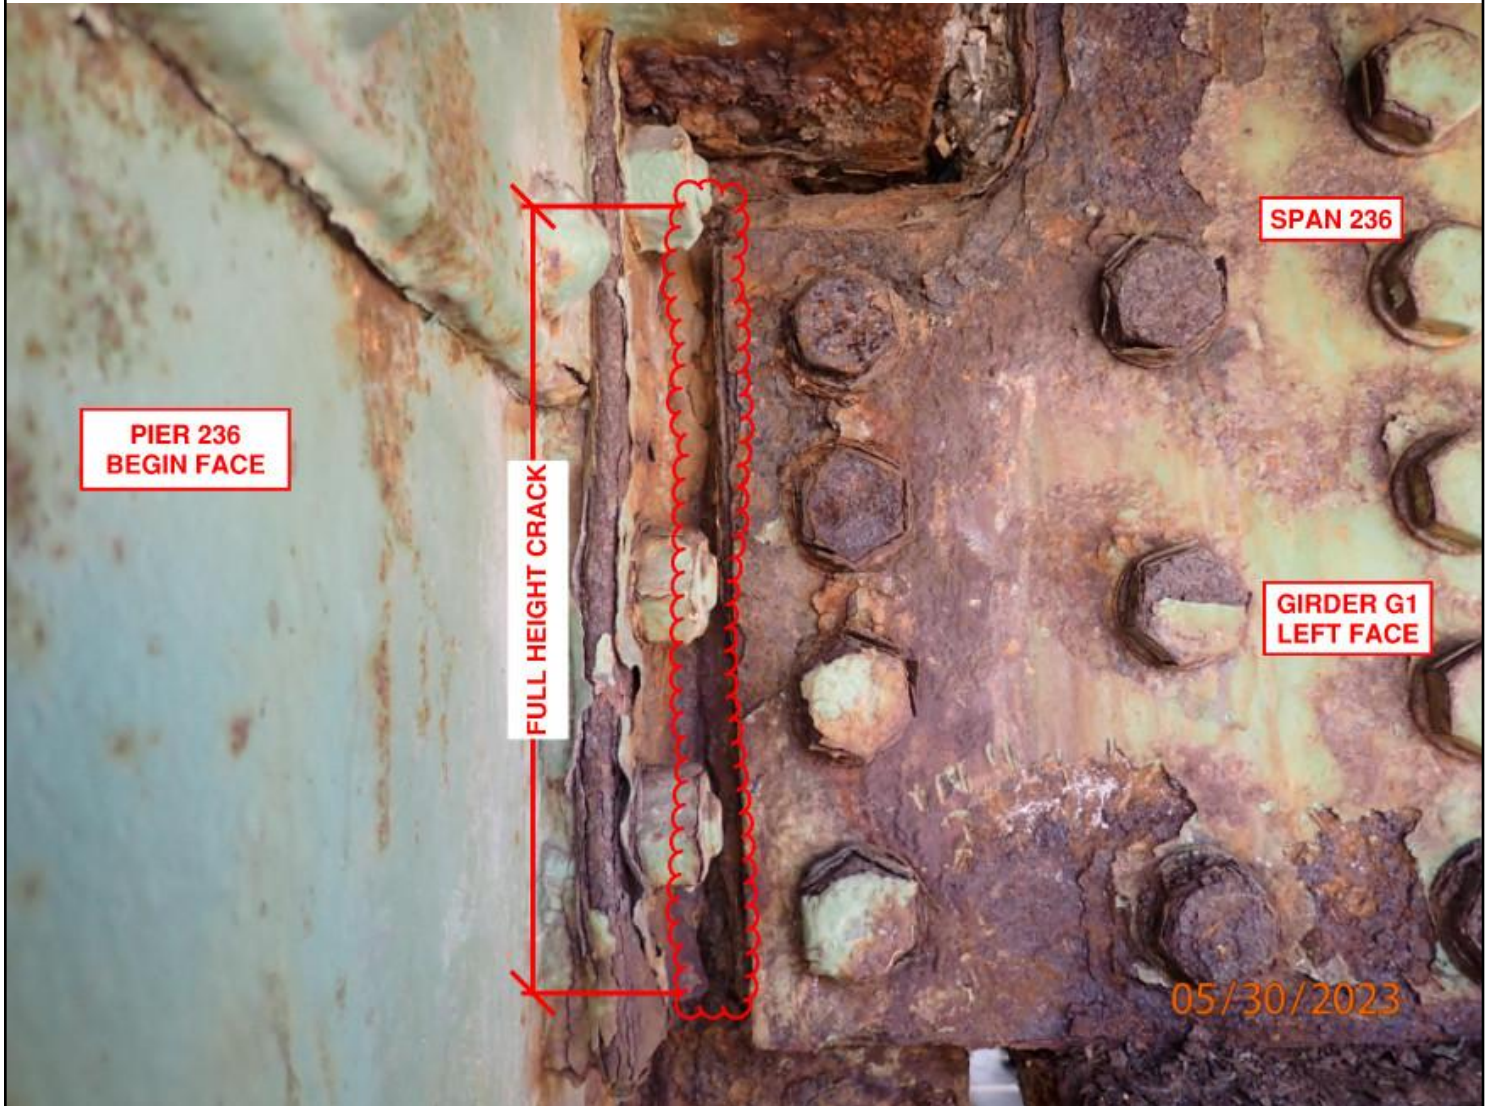
Photo Number: 7

**Attachment Description:** Connection angle with full height crack (1/8 - 1/2" wide) in the connecting leg. Looking Right.

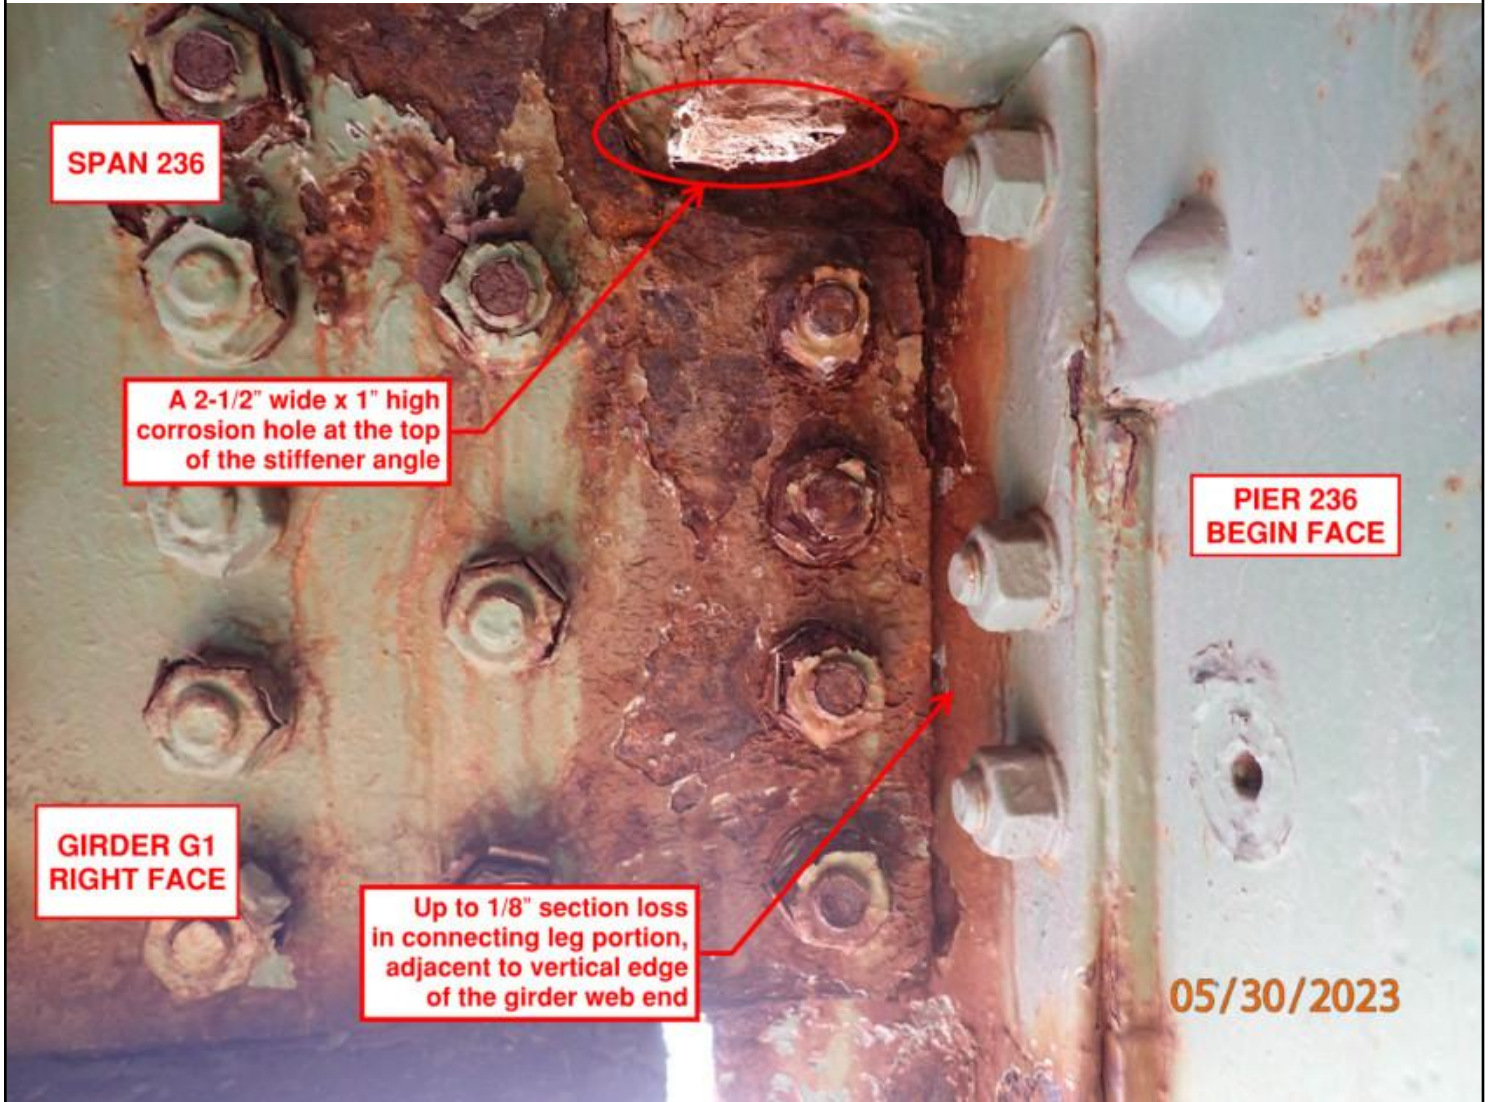
Photo Number: 8

**Attachment Description:** Stiffener angle with Up to 1/8" section loss in connecting leg portion, adjacent to vertical edge of the girder web end, and a 2-1/2" W x 1"H hole at the top of the angle leg. Looking Left.

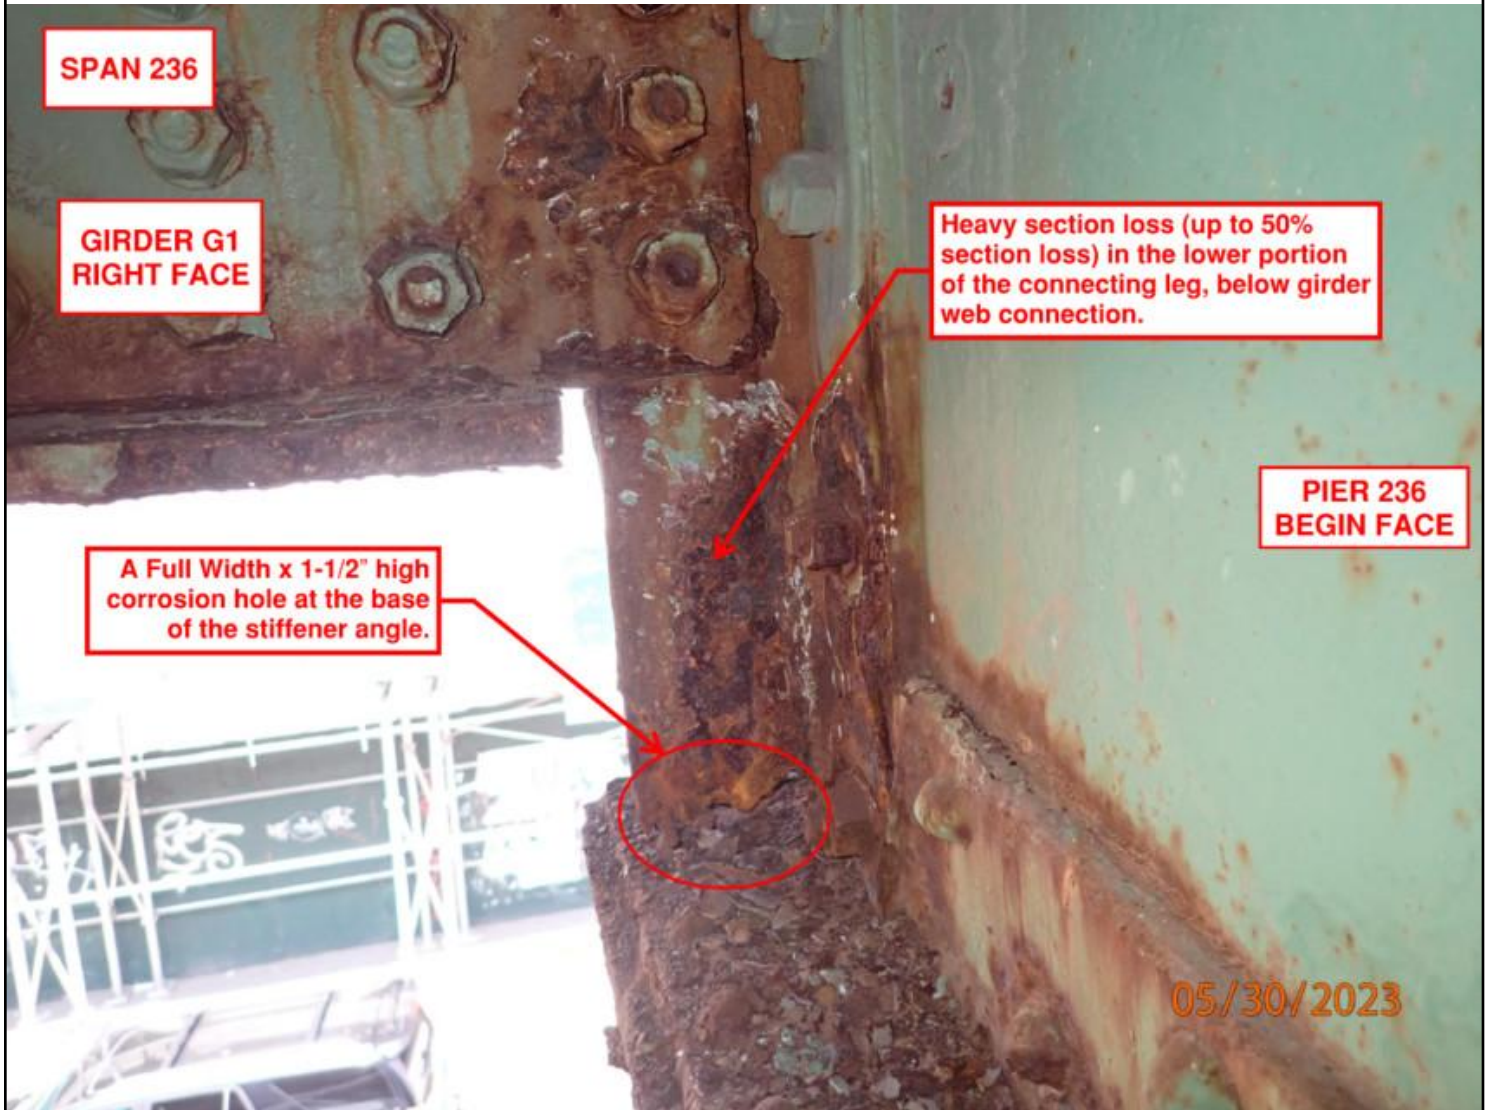
Photo Number: 9

**Attachment Description:** Stiffener angle with up to 50% section loss in lower portion of connecting leg and a Full width x 1-1/2"H hole at the base of the angle leg. Looking Left.
